**DEPARTMENT OF TRANSPORTATION**

Contract #: 04-0120F4Cty: SF/ALA Rte: 80 PM: 13.2/13.9File #: 69.28**WELDING INSPECTION REPORT****Resident Engineer:** Siegenthaler, Peter**Address:** 333 Burma Road**City:** Oakland, CA 94607**Report No:** WIR-019102**Date Inspected:** 24-Dec-2010**Project Name:** SAS Superstructure**OSM Arrival Time:** 700**Prime Contractor:** American Bridge/Fluor Enterprises, a JV**OSM Departure Time:** 1900**Contractor:** Zhenhua Port Machinery Company, Ltd (ZPMC), Changxing Island **Location:** Shanghai, China**CWI Name:** Lv Li Qing**CWI Present:** Yes No**Inspected CWI report:** Yes No N/A**Rod Oven in Use:** Yes No N/A**Electrode to specification:** Yes No N/A**Weld Procedures Followed:** Yes No N/A**Qualified Welders:** Yes No N/A**Verified Joint Fit-up:** Yes No N/A**Approved Drawings:** Yes No N/A**Approved WPS:** Yes No N/A**Delayed / Cancelled:** Yes No N/A**Bridge No:** 34-0006**Component:** OBG**Summary of Items Observed:**

## WELDING INSPECTION REPORT

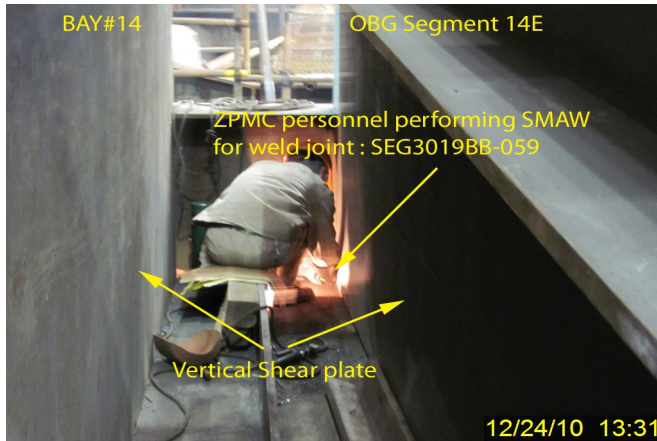
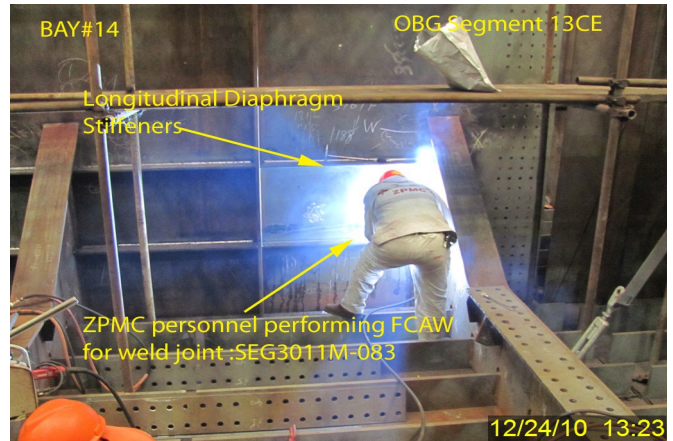
SMAW in the 2G position for the OBG Segment 14E Vertical Shear plate to Bottom plate. The weld joint was designated as: SEG3019BB-059. The welder is identified as #037997. ZPMC QC is identified as Mr. Zhong Guo Hui. The welding variables recorded by QC appear to comply with WPS-B-P-2212-TC-U4B-FCM-1. Please see the attached picture.
